In countries with moist and cold winters with many changes from frost to thaw, bricks must be frost resistant. Nørholm Watermill, which was built in 1792 – the year after Petersen Tegl was founded – is a good example of brickwork that is unaffected by frost.

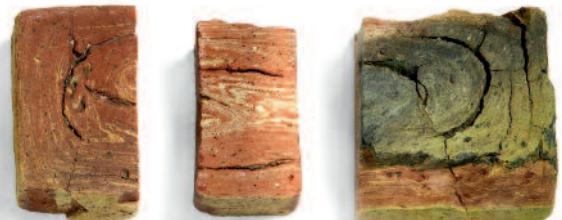
Brick produced in a worm press. The clay is layered, and frost damage has occurred.

Frost damage on clinker-fired bricks appeared only when, about 100 years ago, the worm press was invented. The worm presses the clay into the mould, forming a layered texture, which is clearly seen in the three, red bricks to the left. Due to the texture of the clay*, these layers may work as "flat" capillaries, sucking full of water. When the water freezes, these layers are pressed apart, and frost cracking may develop, which is clearly seen in the perforated brick to the left.

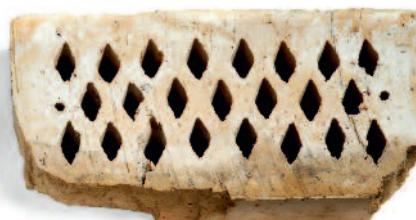
Perforated brick with frost damage
